Remediation in High Complexity Site - Successful Combination of Different Technologies In a Chlorinated Solvent Contaminated Area

Background / Objectives

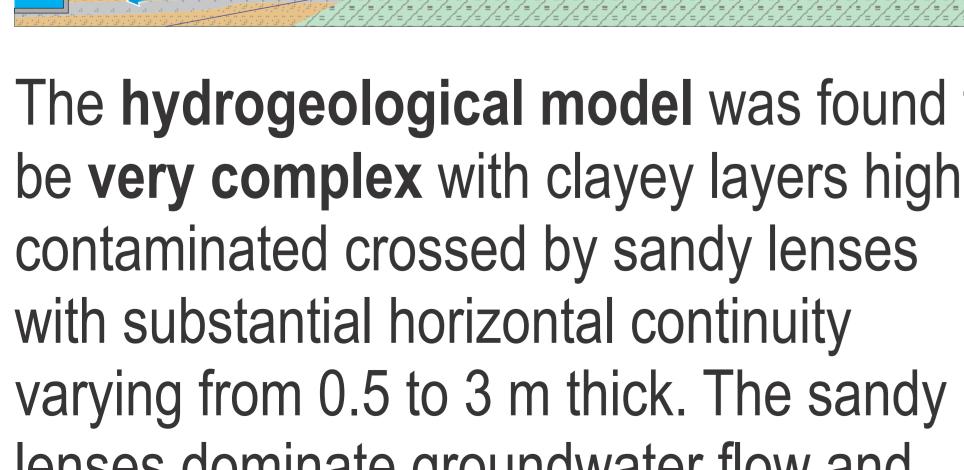
Silte Areia multo fina Areia fina Areia média Areia grossa Areia multo Areia Tota grossa Areia multo Areia Tota grossa 16
1 1 1 1 0
Sitte Areia multo fina Areia fina Areia média Areia grossa Areia multo
Areia fina Areia fina Areia fina Areia fina Areia grossa Grossa

AMI-05 (16,10M) → % acumulada grossa

The hydrogeological model was found to Red to grey compact clay with ocher silty lenses Groundwater flow be very complex with clayey layers highly Former effluent box Silty sandy clay, variegated, sometimes less sandy, silty and friable in the ocher portions Former effluent pipes Sandy clay to claiey sand Excavation area Sand Schematic VOC plume Purple compact clay DNAPL lenses dominate groundwater flow and Quaternary sediments: silty clay sometimes sandy, with quartz crystals not very angular contaminant transport. Quaternary sediments: organic clay

After understanding the site's complex hydrogeological model, the aquifer was divided into four hydraulic levels, confined by the clayey layers. The shallower level was considered the most important, due to the potential of vapor intrusion and, consequently, human exposition to contamination.

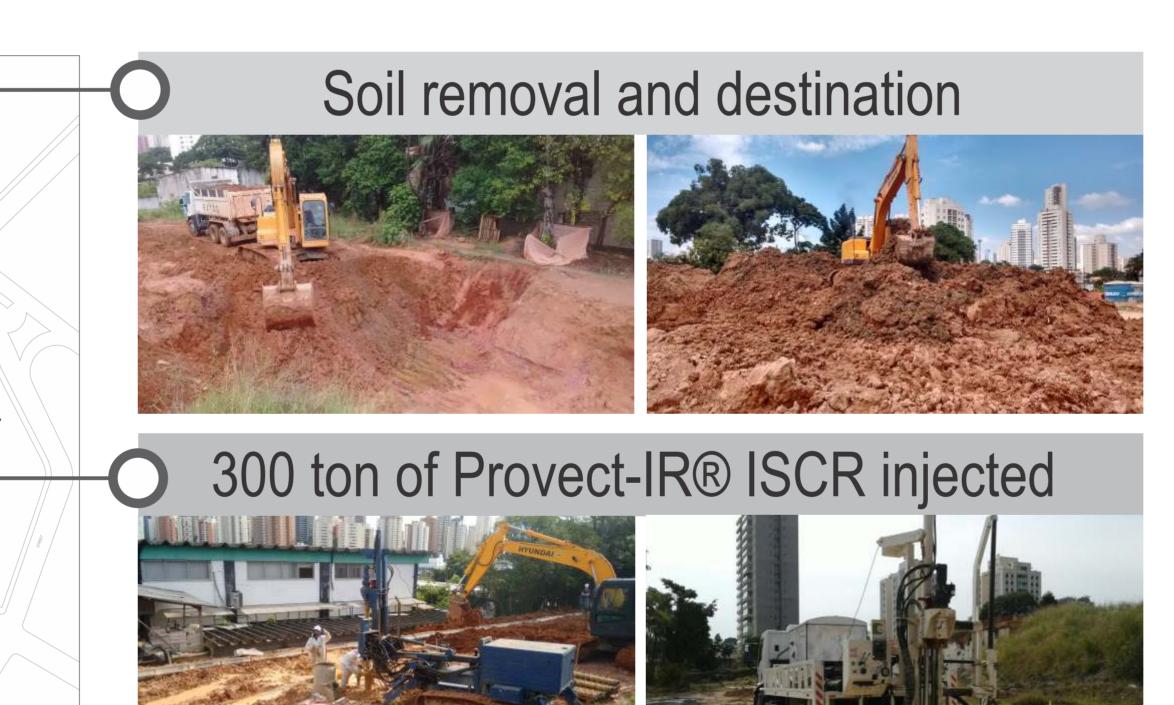
MPE for DNAPL recovery and SVE

The remediation strategy considered a synergistic combination of techniques: soil removal and destination, multiphase extraction (MPE) for DNAPL recovery and in situ chemical reduction (ISCR), aiming the regeneration of the area for residential occupation. Additionally, soil vapor extraction (SVE) was employed to mitigate potential risks for the human receptors in the neighboring buildings.

The field scale remediation included the removal and off-site disposal of 24,300 ton of contaminated soil (mainly clay, in which ISCR wouldn't be effective) and in situ groundwater treatment through the injection of 300 ton of antimethanogenic Provect-IR® in 537 points with multiple injection layers, due to contaminant distribution. Monthly measurements of pH and ORP were performed to evaluate the formation of the reactive zones.

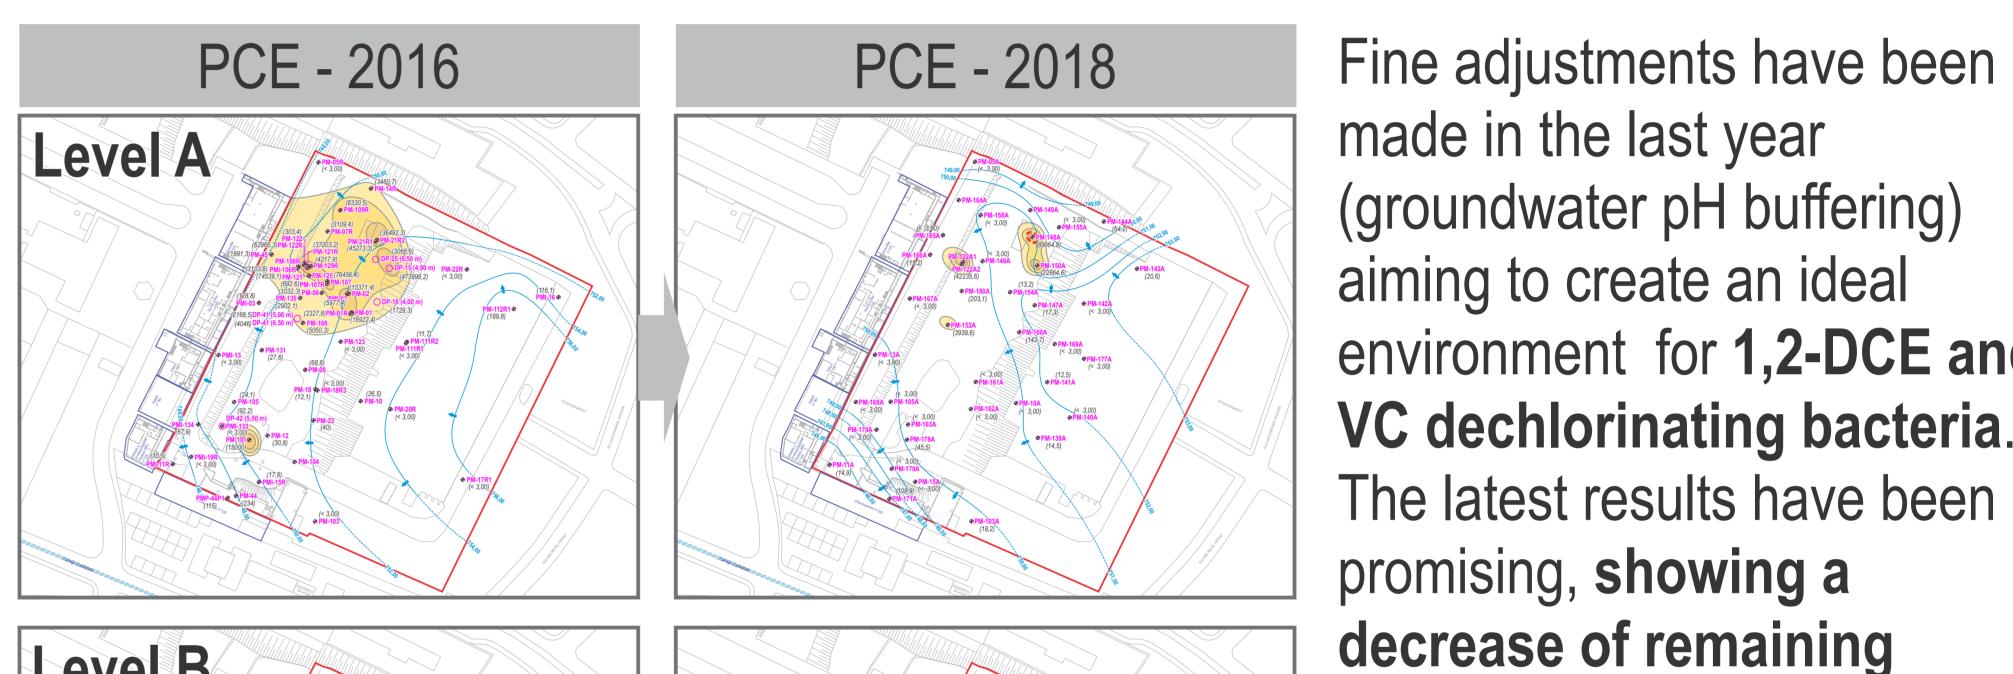
Level B

After 3 years since the beginning of the remediation a reduction of 89% in the total VOC mass was observed. Most of monitoring wells had concentrations of all COCs below the calculated SSTLs.

Only a few still showed 1,2-DCE and VC concentrations above target levels, but below 10,000 µg/L (much lower than baseline concentrations) and without parent compounds rebound.

environment for 1,2-DCE and VC dechlorinating bacteria. The latest results have been promising, showing a decrease of remaining
